**Subject: Annual Inspection Report
Grove Hill Municipal Airport**

JULY 6, 2011

ANNUAL INSPECTION REPORT

GROVE HILL MUNICIPAL AIRPORT

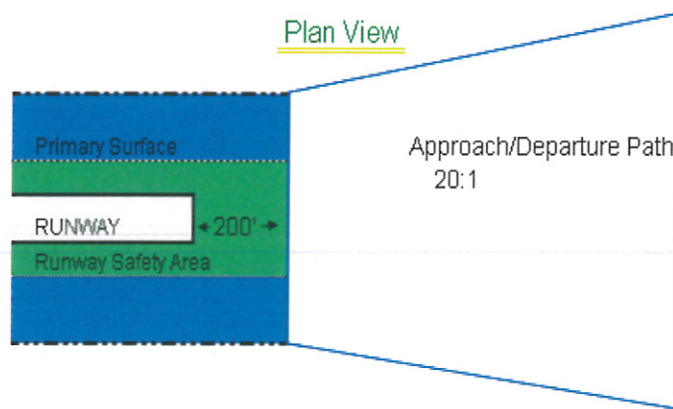
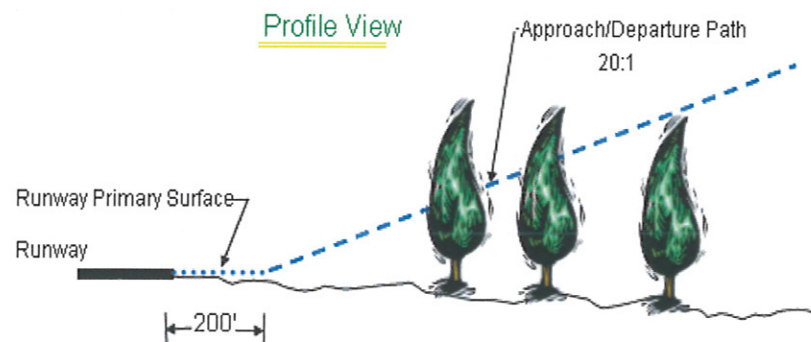
APPENDIX 1

Approach and Departure Path Dimensions			
Inner Width	Outer Width	Length	Acreage
250 Feet	450 Feet	1,000 Feet	8.04 Acres
Primary Surface Dimensions			
250 Feet Wide Centered Along Runway Centerline			
Extending 200 Feet Past the Runway End			
Runway Safety Area Dimensions			
120 Feet Wide Centered Along Runway Centerline			
Extending 200 Feet Past the Runway End
